Authority for Nuclear Safety and
Radiation Protection

Report on events in Dutch nuclear facilities during 2015

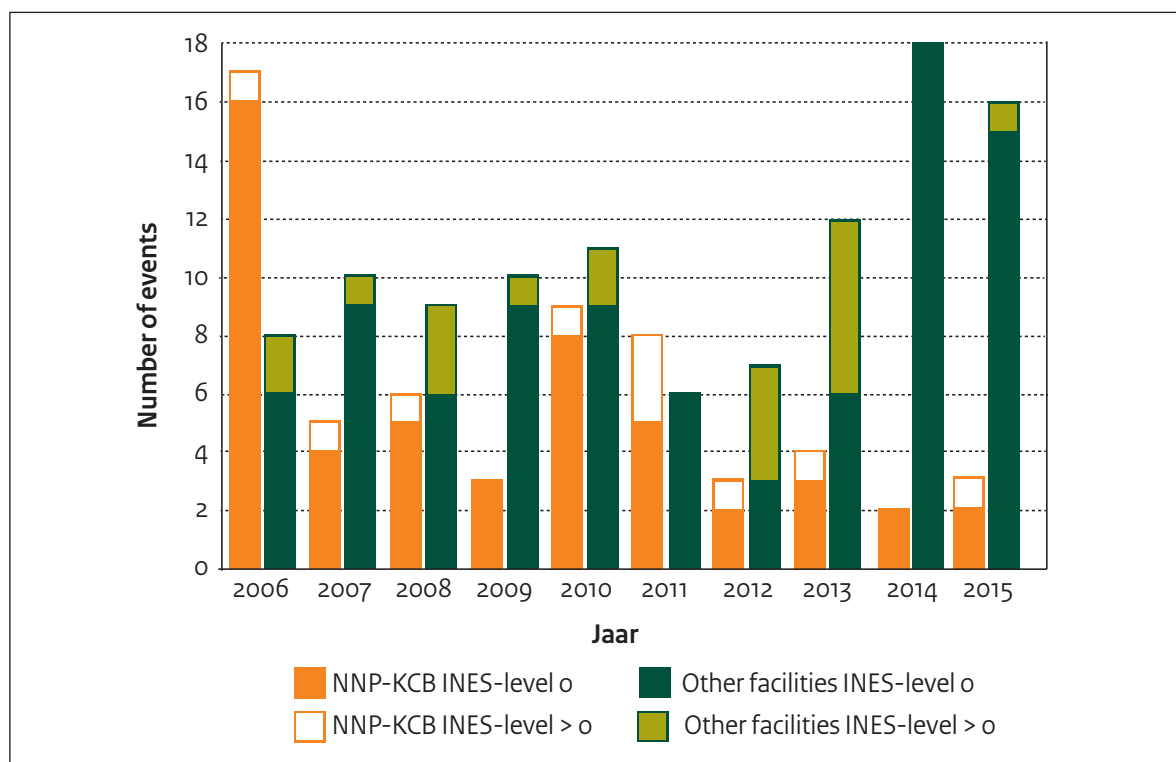
Figure 1: The number of events subject to a reporting requirement which occurred at the NPP-KCB and other nuclear facilities from 2006 up to and including 2015.

For the purposes of information, Table 2 shows a summary of the events which have occurred in the last ten years, from 2006 up to and including 2015. The information has been broken down into events which have occurred at the KCB and those which have occurred at other Dutch nuclear facilities. The table also contains a summary of all the events rated at an INES level higher than 0. Figure 1 shows this information in a graph.
